GLASMALEREI PETERS STUDIOS

Studio for restoration and conservation since 1912

| <b>St. Maria, Altenberg (Altenberg Cathedral)</b> | |
| Restoration of the Gothic west window and installation of protective glazing | 8 |

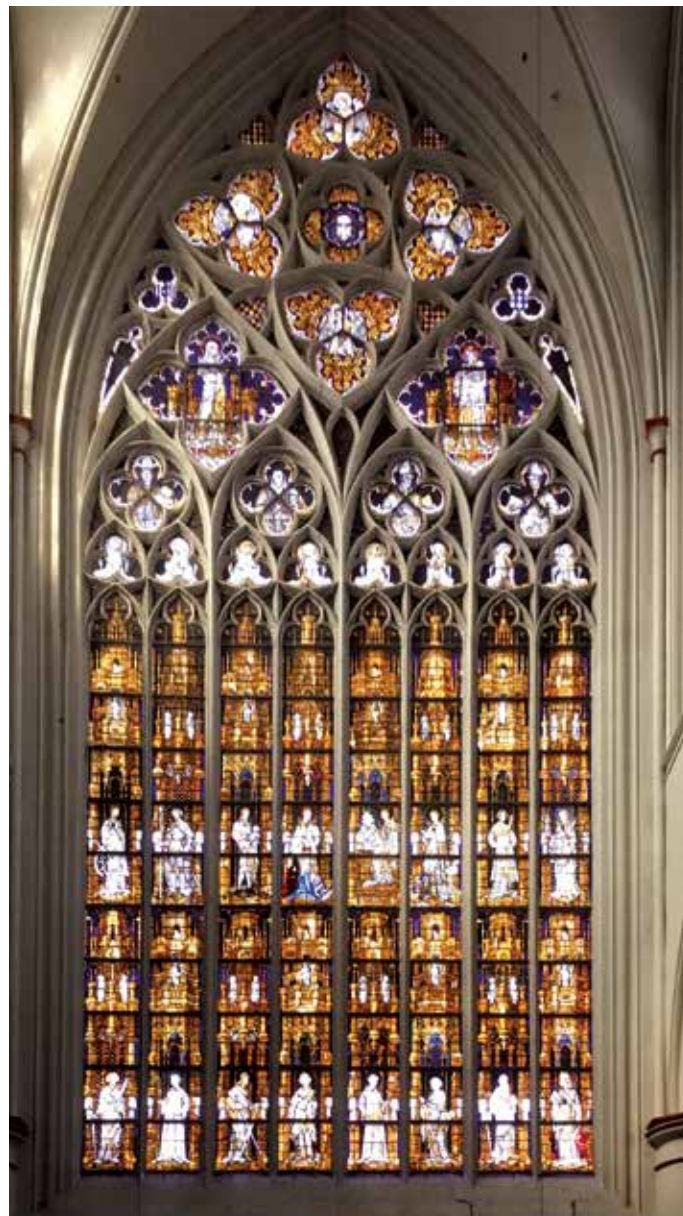
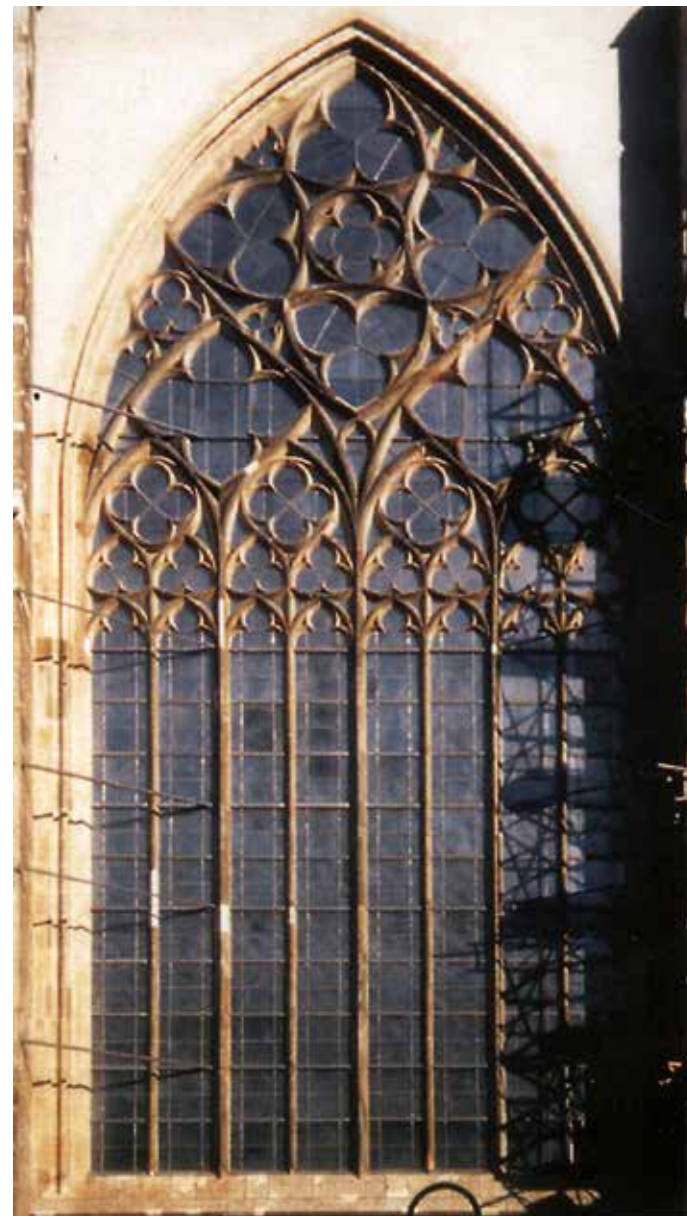
Fig. 1 - Glass sensor on the inside

In order to monitor the effectiveness of the protective glazing in the long term, glass sensors were installed on the outside and inside and in the interstitial space in cooperation with the Fraunhofer Institute for Silicate Research. The influence of moisture, temperature changes, pollutants and microorganisms at the point of use is quantified at the glass sensors in the laboratory by IR spectroscopy and recorded with a simple numerical value (E-value).

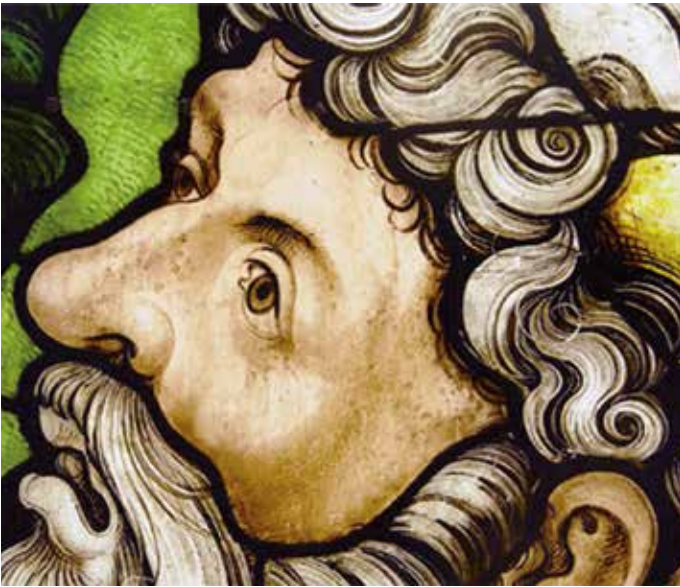
Moses' head without retouching - condition today

By superimposing the photographic status quo and the scan data, it was possible to make parts of the lost contour drawings and the internal hatchings of painted objects legible again. On the one hand, the results are relevant for the reconstruction of artistic concepts and the attribution of drawing styles to stained glass workshops. On the other hand, conservators have the possibility to reconstruct the contours or hatchings virtually and in reality.

A virtual retouching was made on the detailed section of Moses' head on the basis of the photograph from 1943 and the current 3D scan.

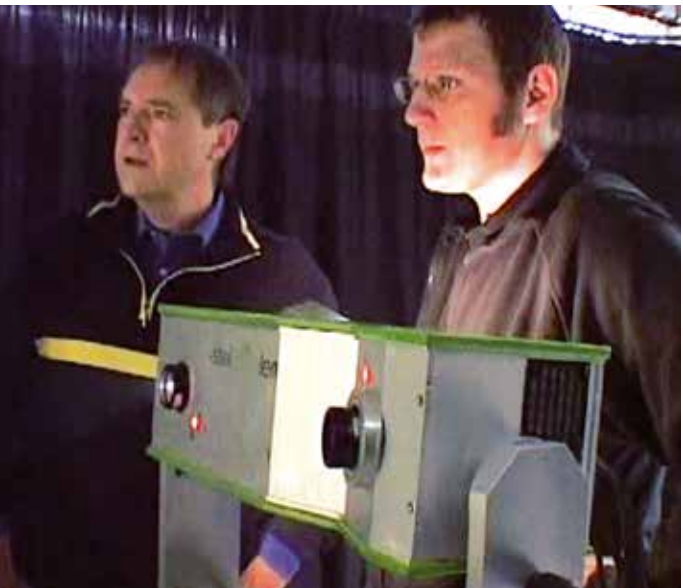
3D scanner - cooperation with the University of Bamberg

The method considered was non-contact 3D white-light strip projection, with which the topography of surfaces can be recorded without distortion and geometric data for black-lot-based glass paintings have a high informative value despite their colour neutrality. By comparing the status quo with older photographs, time series analyses can be made from which material losses or the occurrence of deformations and stress cracks can be deduced. Another option of the method for some types of glass is the detection of surface defects and the visualisation of fire residues or optically conspicuous corrosion layers.

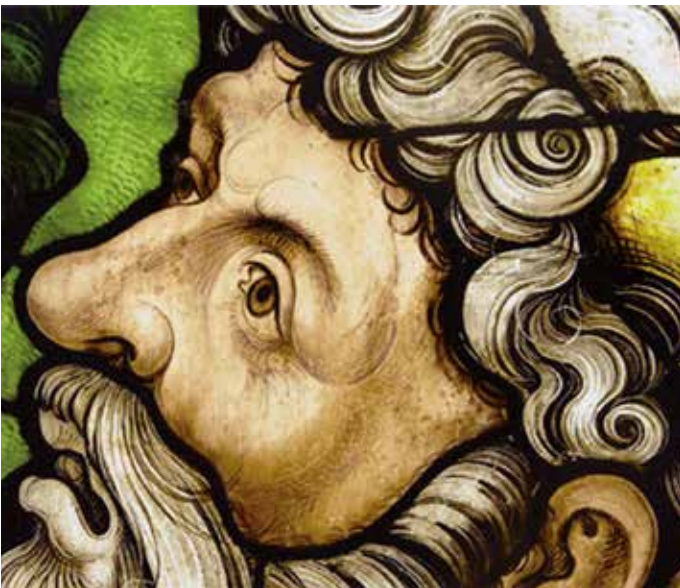
Moses head with heavy retouching, approx. 100% possible condition in the period of origin. All hatching lines are not clarified.

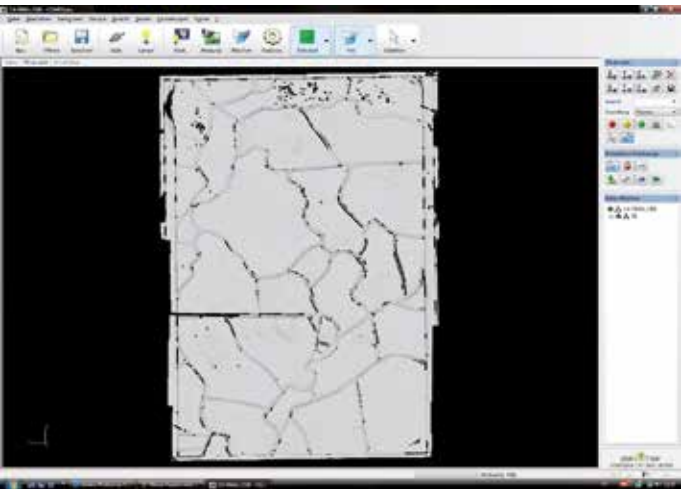
3D scan on the monitor

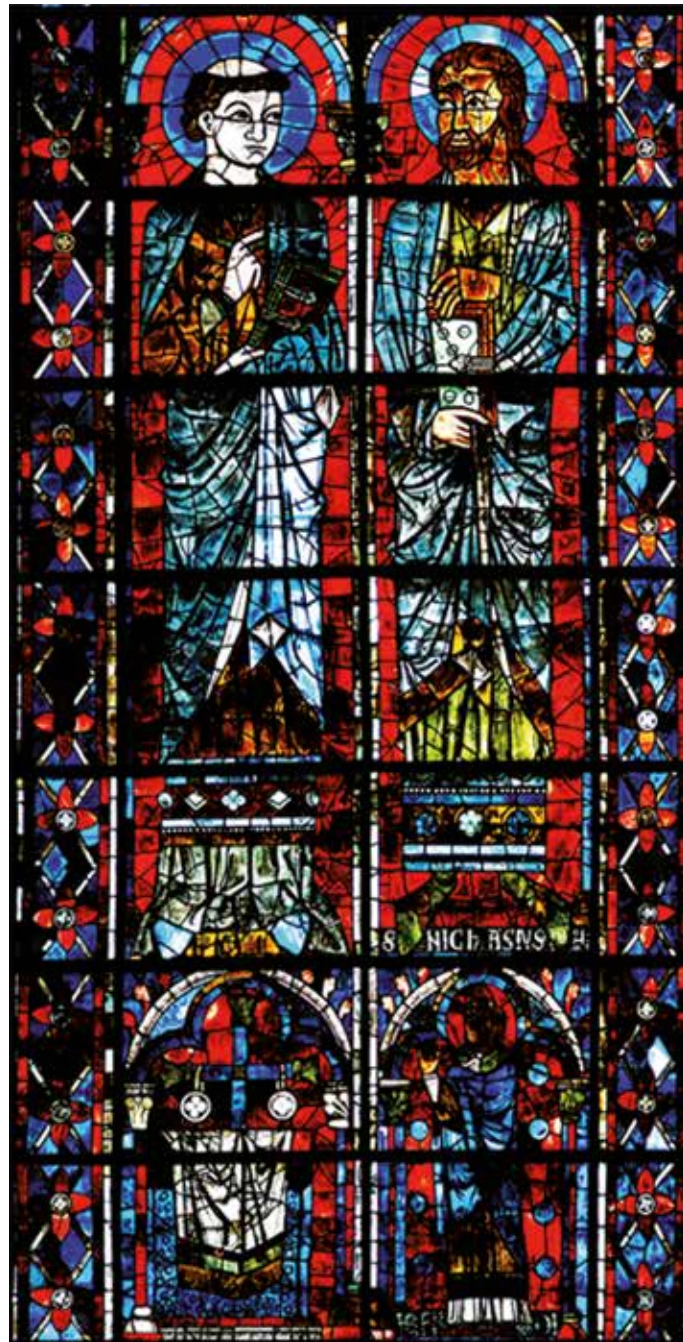
12 Window 116, lancet A before restoration

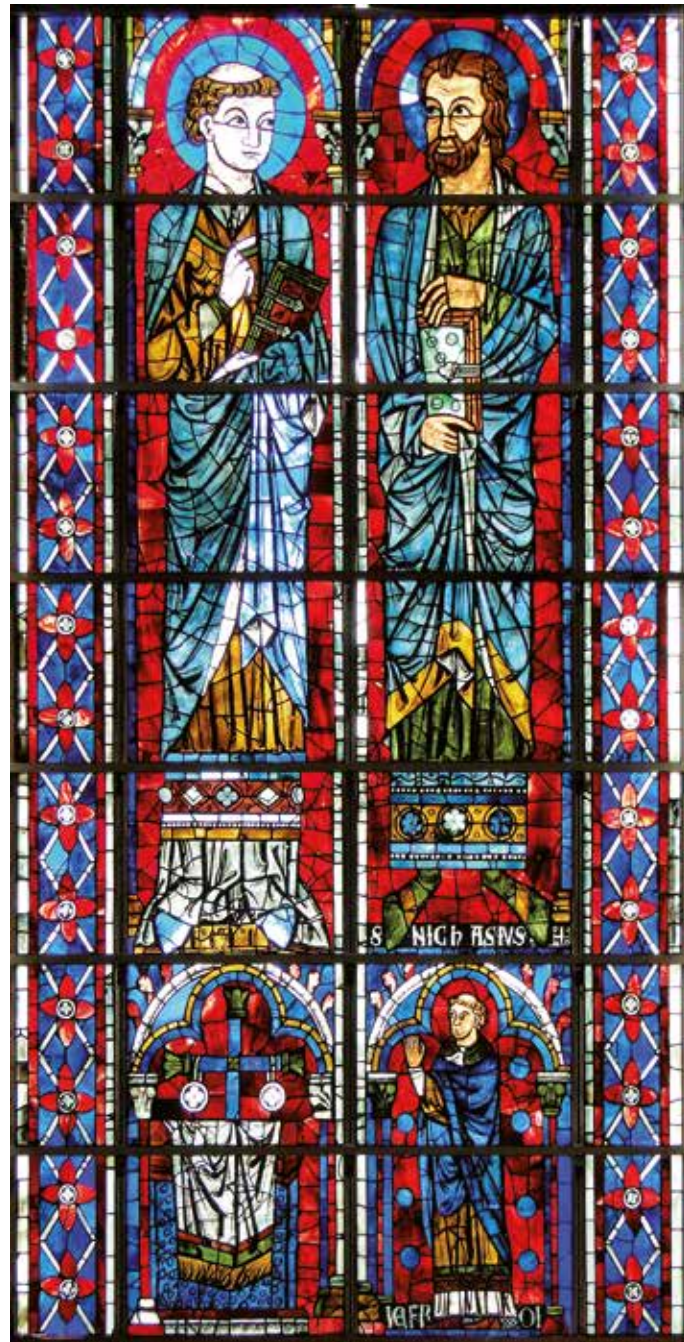
Window 116, lancet A after restoration

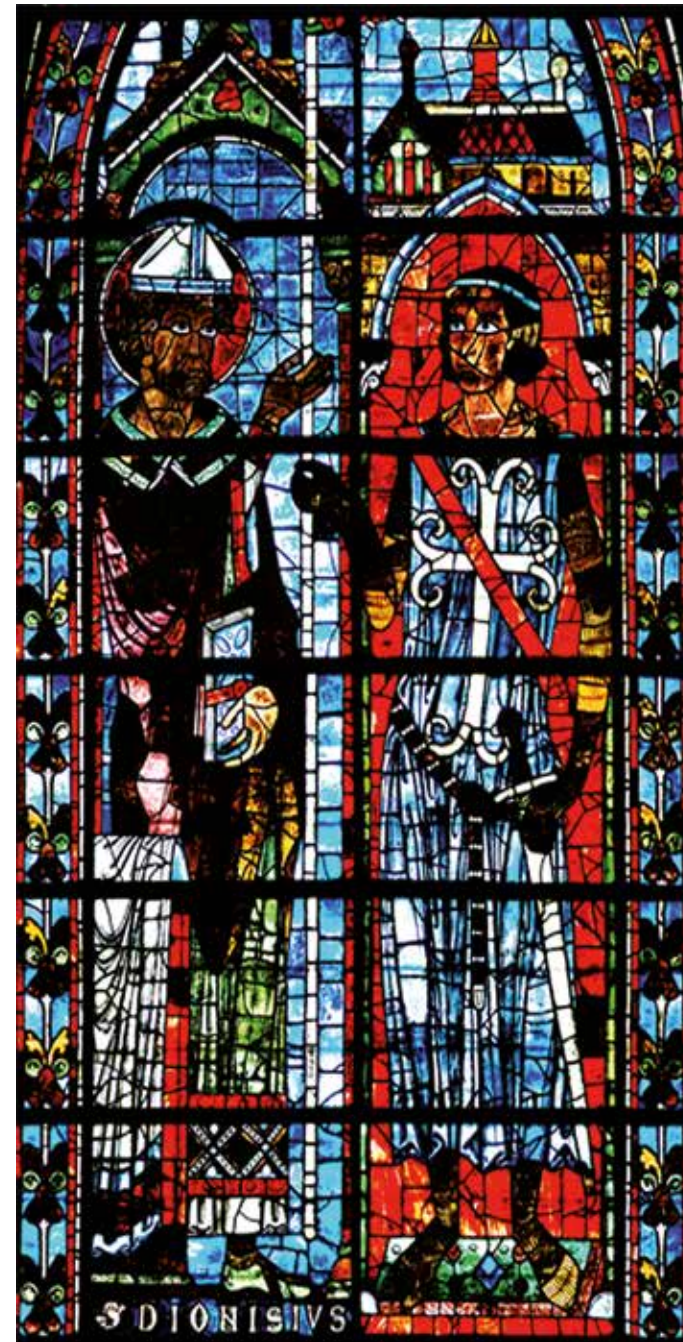
Window 116, lancet B before restoration

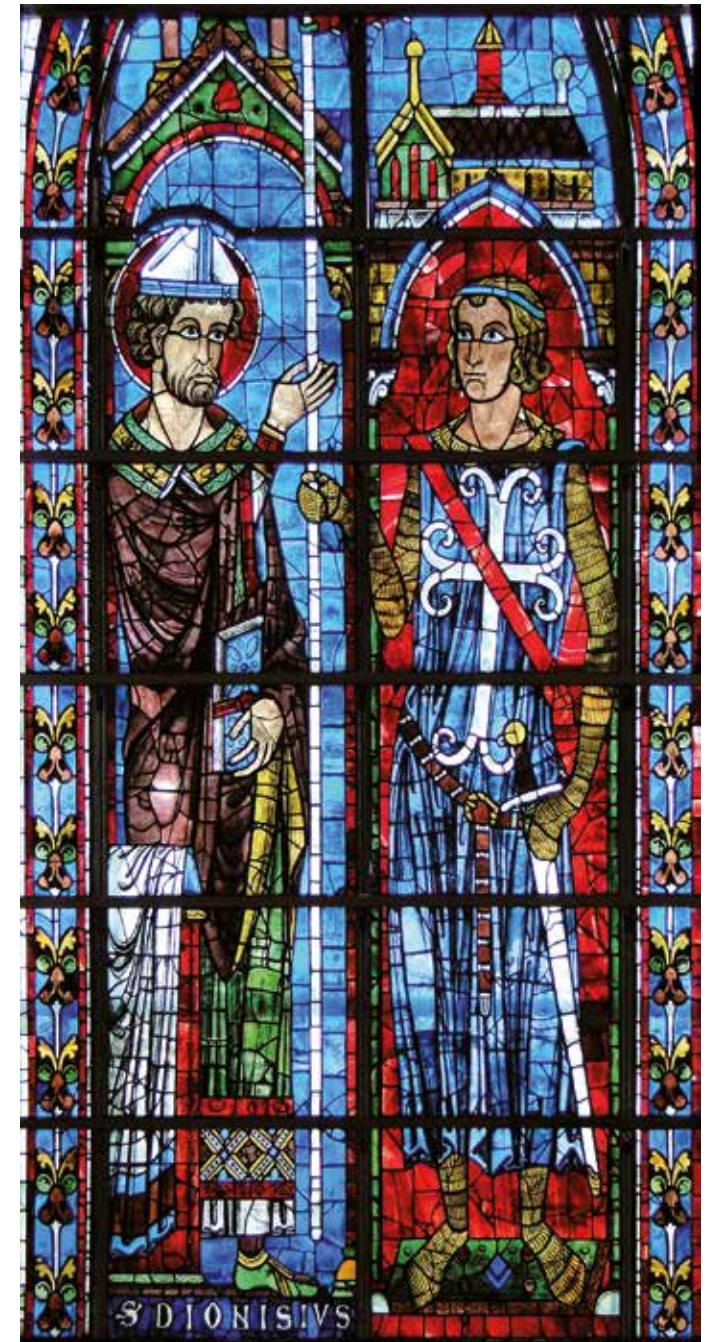
Window 116, lancet B after restoration

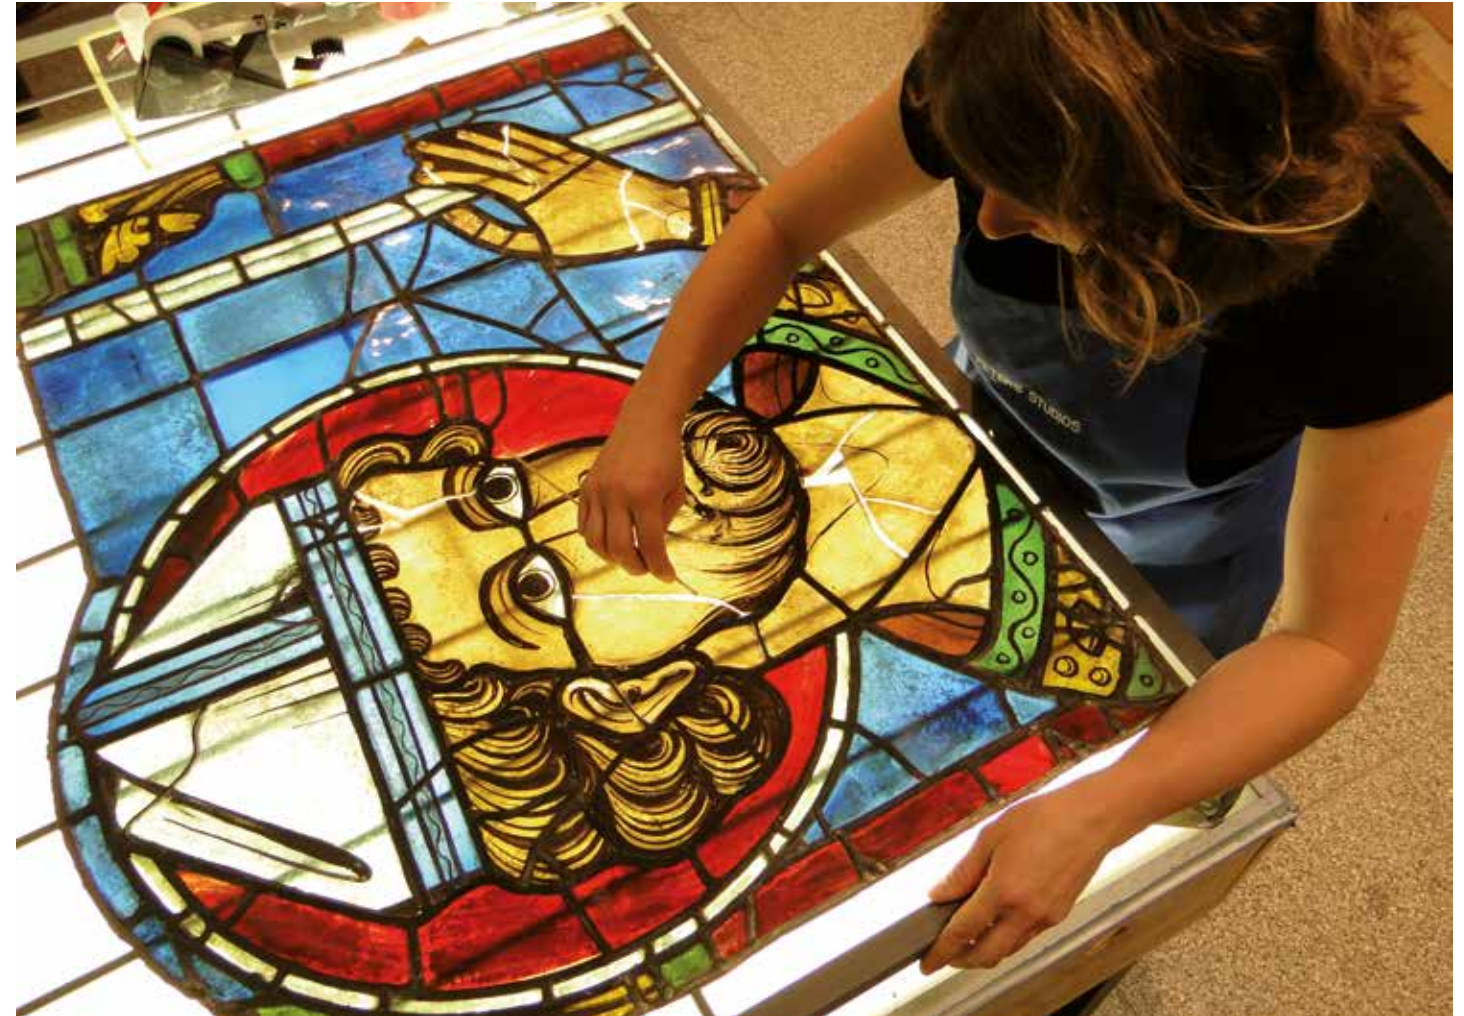
Removal of the emergency leads and bonding of the cracks

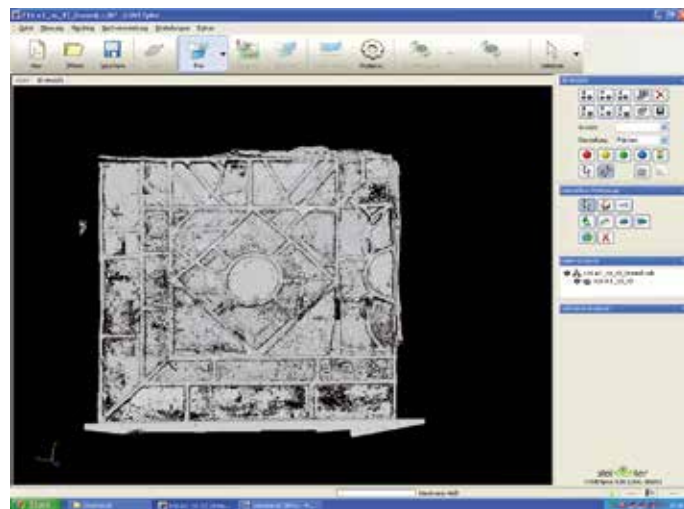
Result of a 3D white light scan

As an example, a 3D white light scan was also carried out on one field. In cooperation with the University of Bamberg, this device was tested for topographical surface analysis in order to obtain detailed information about the removal of dirt and corrosion layers and, if necessary, to make lost painting visible again.

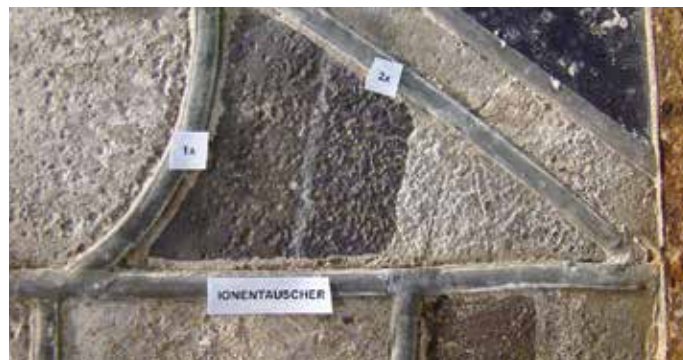
Cleaning with ion exchanger

The ion exchangers used are a resin that is applied in solid form and activated by distilled water. The process can be precisely monitored and controlled by the solid application form. Other agents such as EDTA, on the other hand, can be reactivated by condensation in the form of dried residue on the glass, causing further damage to the glass. The cleaning method we used, on the other hand, is absolutely risk-free and thus optimal from the point of view of monument preservation.

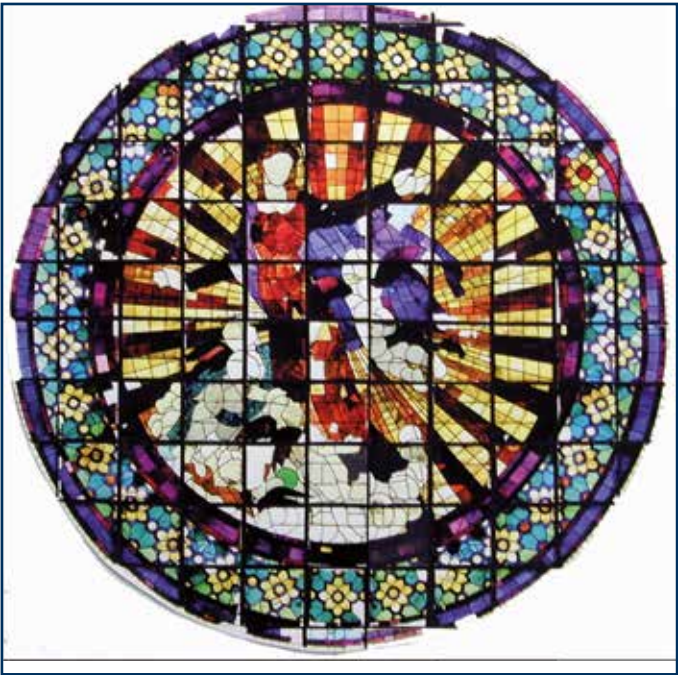
West rosette before restoration

The rosette windows were for the most part original, apart from a few pieces of repair glass and a field in the east rosette that was inserted later. On both rose windows, there were a large number of cracked panes and, in some cases, missing parts in the glass. There was conspicuous surface damage in the form of a grey haze that appeared exclusively on the violet glass. Most of the painting was very badly damaged due to the loss of adhesion. In large areas, the paint layer had peeled off over a large area and the original design could only be seen at close range and under grazing light. The missing coatings had an aesthetically disturbing effect, especially in the figurative areas.

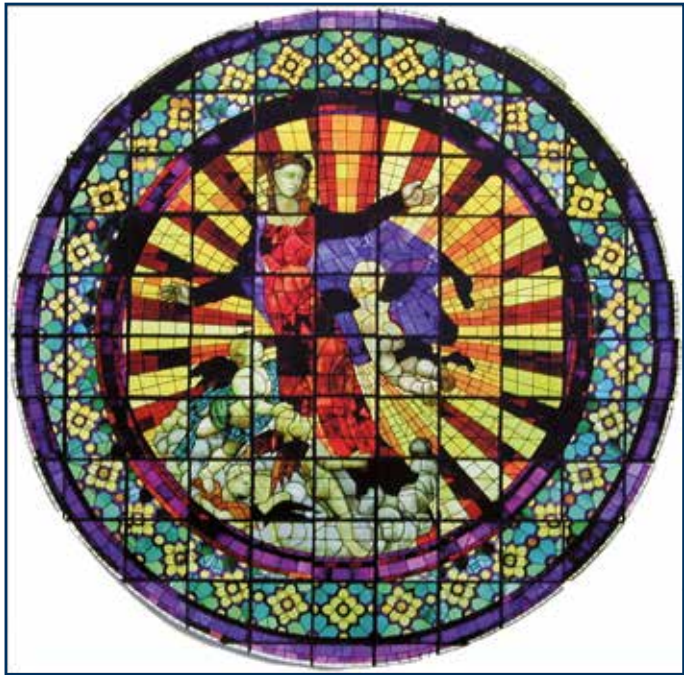
West rosette after restoration

were applied to a separate clear glass pane with the classical glass painting colours and burned in. During assembly, these panes were then mounted in a package with the corresponding original glazing, restored to legibility in transmitted light, but without altering the original substance. The additionally attached clear glass pane can be removed at any time with little effort. Both rose windows have received additional internally ventilated protective glazing for protection.

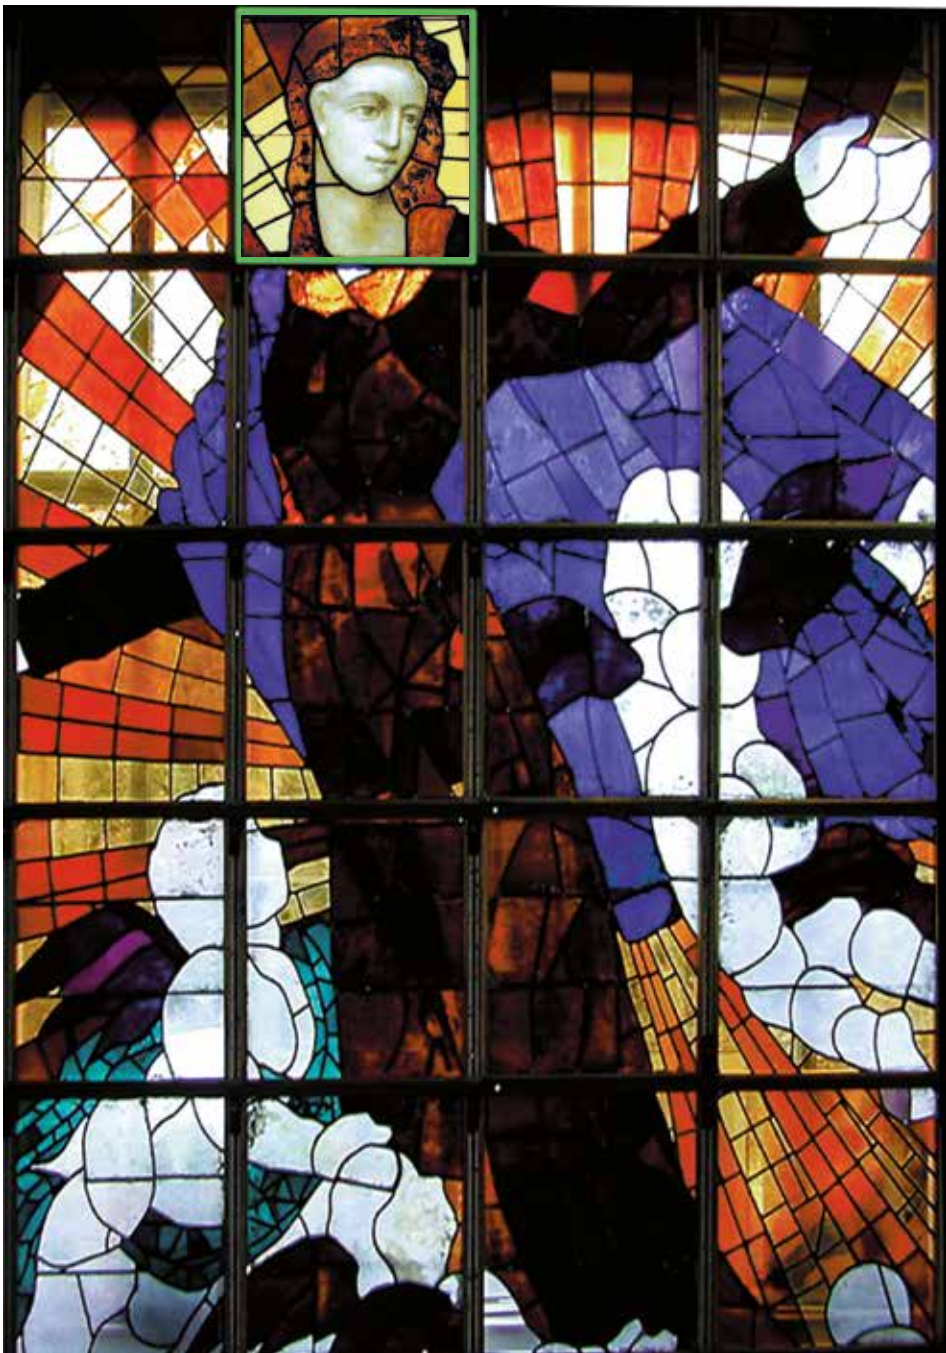
Original and doubling pane

Since the loss of the painting was very extensive, partial doubling panes were discarded and all supplementary contours and overlays

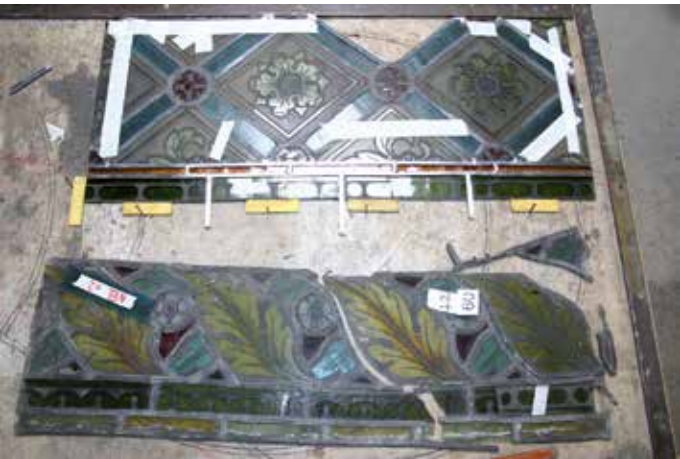
Assembling the fragments in the workshop

Four of the original ten windows could be reconstructed on the basis of the glass fragments found and sorted. At the beginning, it was planned to detach all the glass pieces from the existing lead nets and to lead them anew. However, the original lead nets could be formed back, preserved and supplemented with a few new lead rods to form complete windows. Through this measure, much of the original substance was preserved.

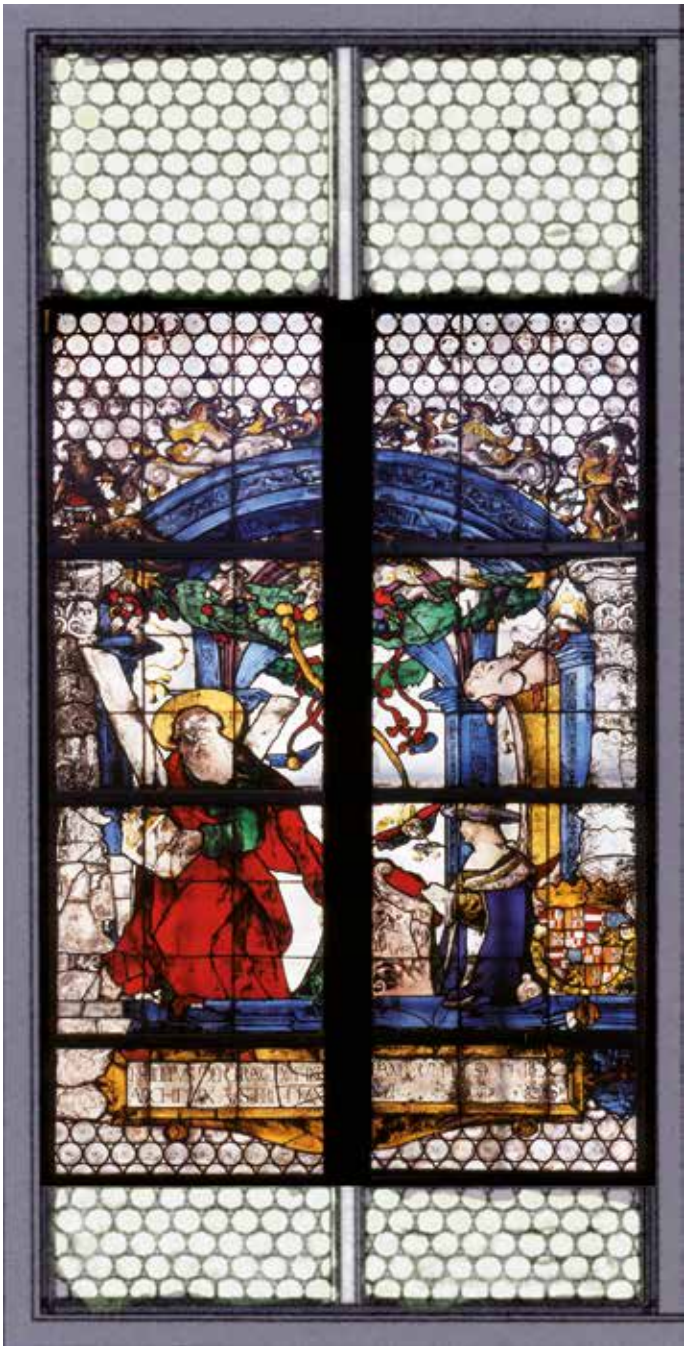
Original pane - detail

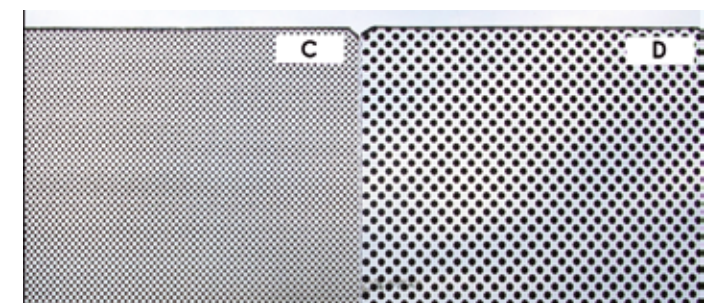
Grid samples in different sizes

However, too coarse a grid ran the risk of dissolving the effect of the picture. The window glazing should blend harmoniously into the architecture, complete the intact overall picture of the interior, and then become recognisable to the viewer as a reconstruction when seen up close. In this way, it was possible to meet the demands of the preservation of historical monuments for a reconstruction that could be restored ethically and the wishes of the church visitors for a coherent overall picture.

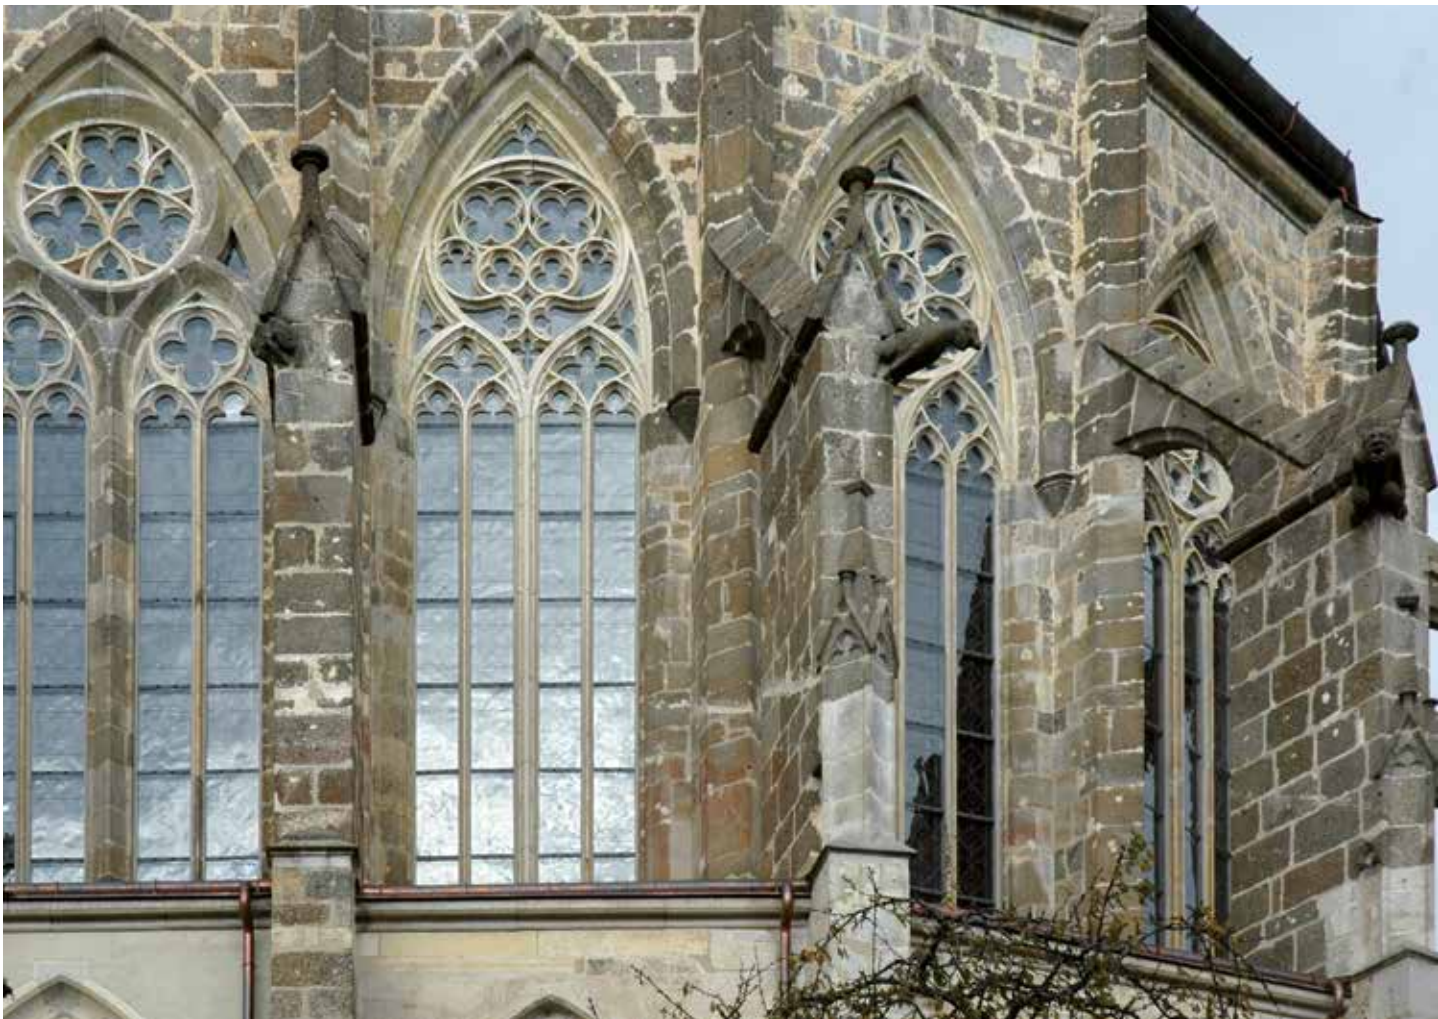
Exterior view of a furnace-formed protective glazing

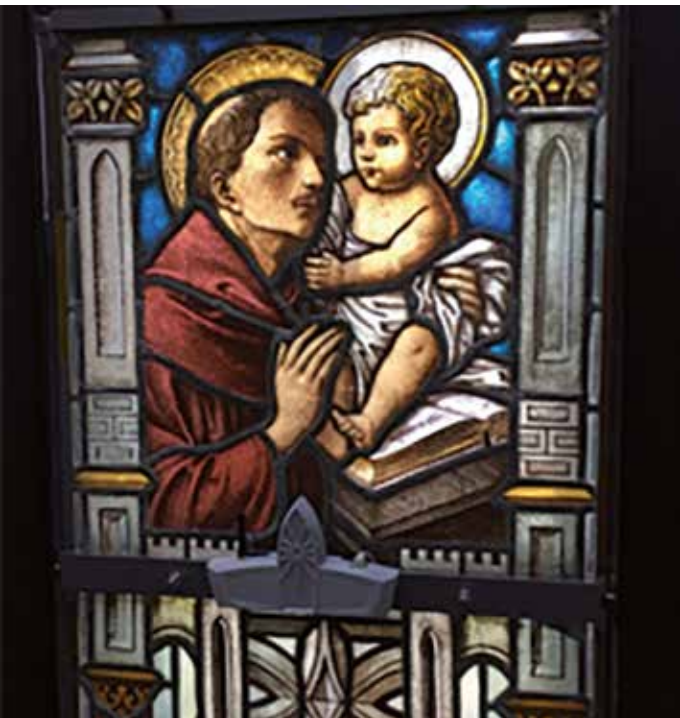
Installation situation main module

The sensor system is optimally adapted to the structural and climatic conditions of protective glazing.

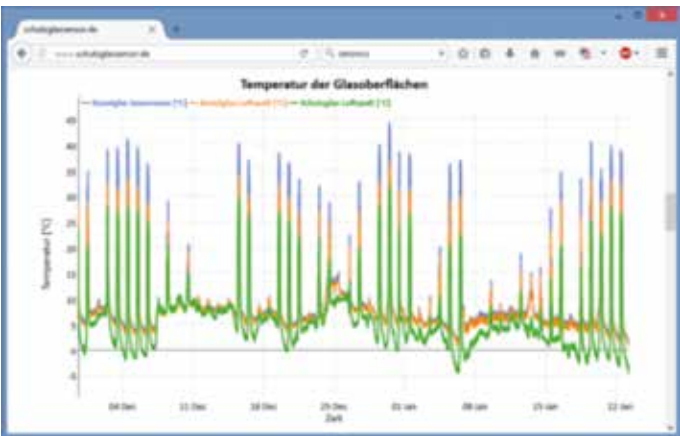
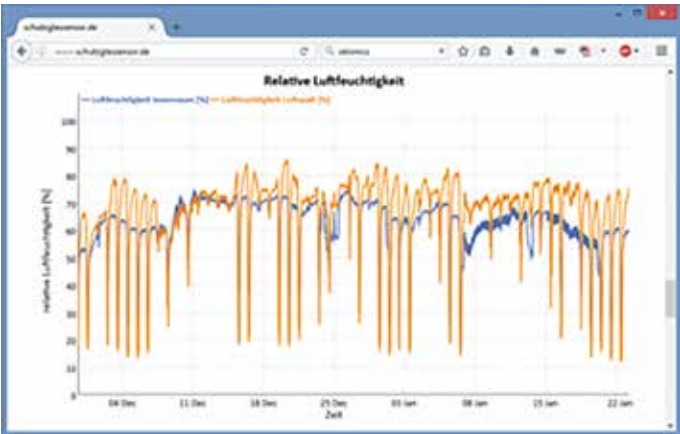
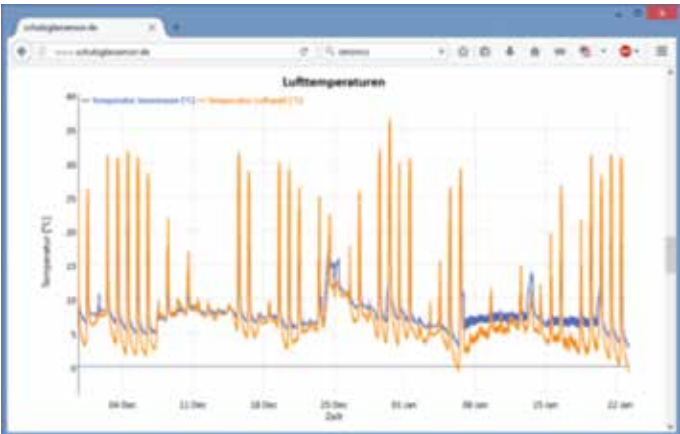
Measurement data diagrams in the Internet portal

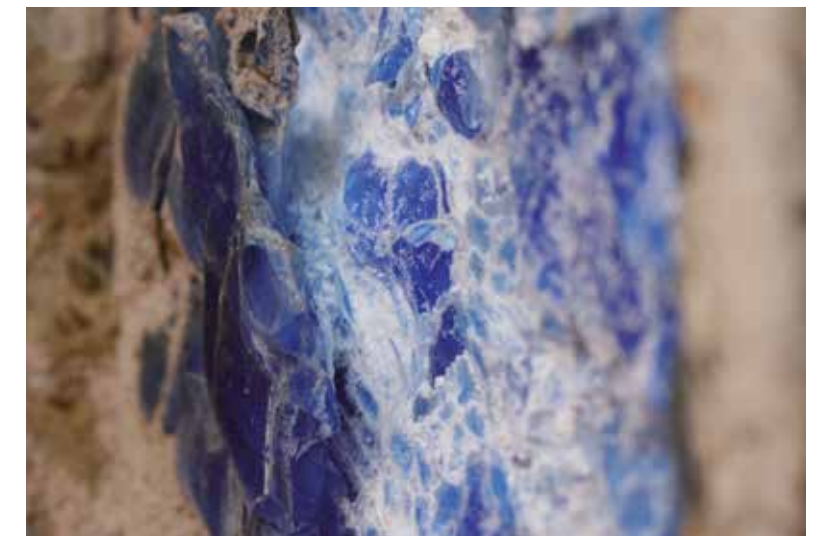
Chipped glass surface

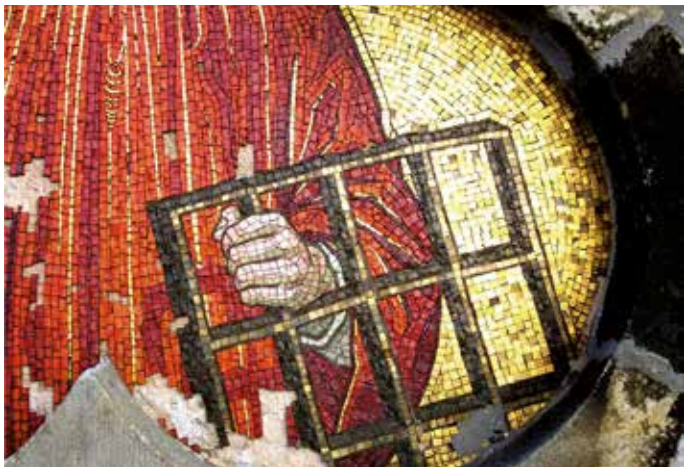
damaged mosaic

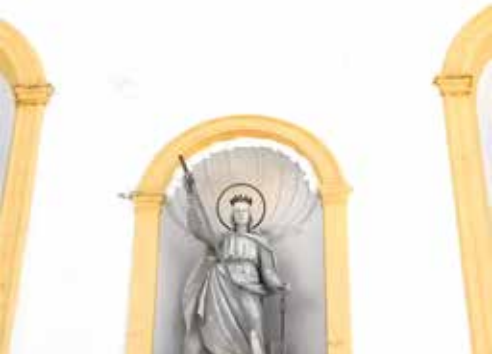
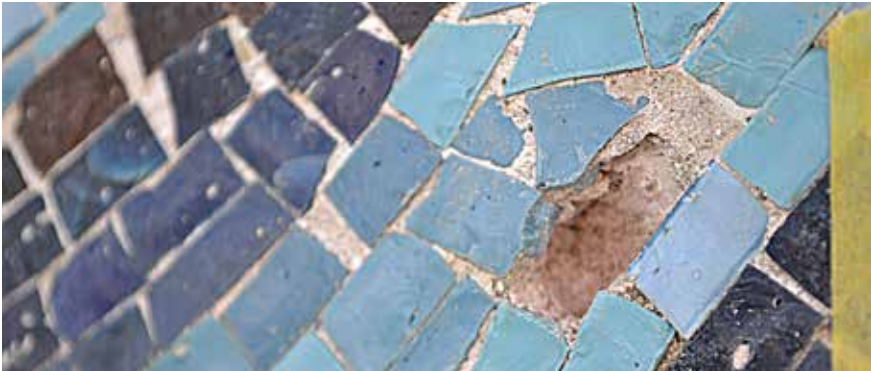
Defective areas

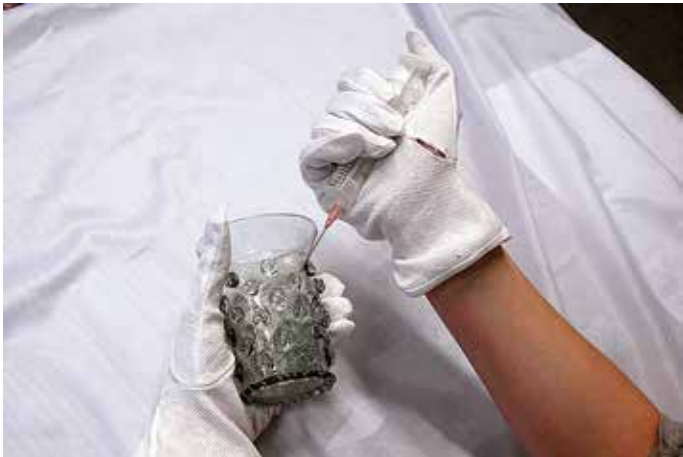
Filling in the adhesive

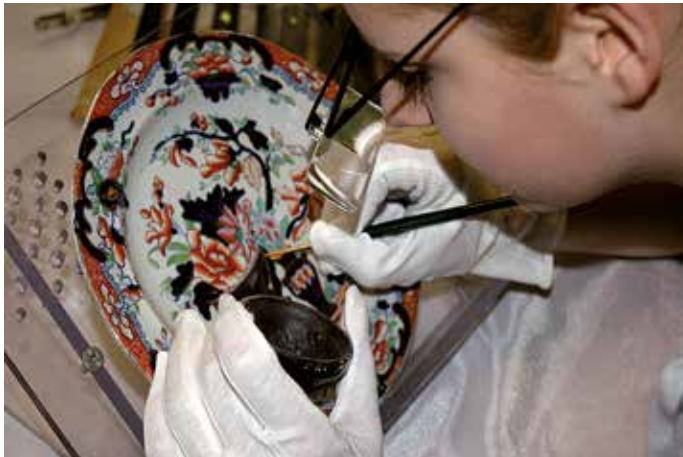
Retouching the bonding with the help of magnifying glasses
